NL INDUSTRIES/TARACORP SUPERFUND SITE GROUP
Leed Environmental, Inc.
Van Reed Office Plaza
2209 Quarry Drive, Suite C-35
Reading, PA 19609
Telephone: (610) 670-7310
Facsimile: (610) 670-7311

Re: NL Industries/Taracorp Superfund Site; Granite City, Illinois
Second 2016 Semi-Annual Operation and Maintenance Inspection (November 2016)

**NL Industries/Taracorp Superfund Site
Inspection Log - Operation and Maintenance**

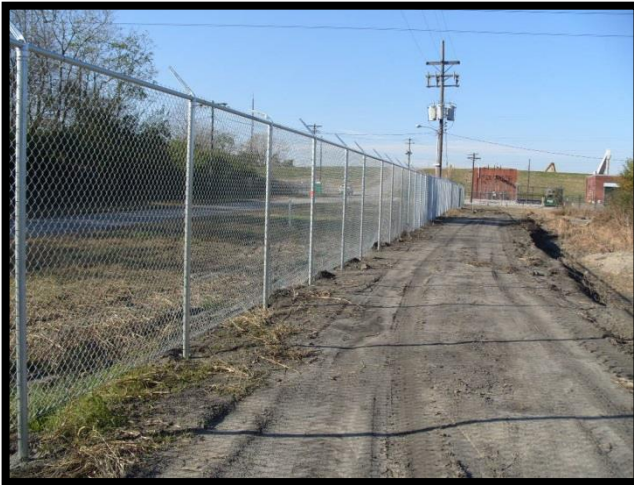
- Also regarding Slough Road, and as shown in Attachment 1 (photographs 1, 2, and 13-16), Beelman has recently installed perimeter security fence around its warehouse building. The perimeter security fence extends along Bremen Street on the south end of the Slough Road area. The fence and locked gate along Bremen Street restrict access to Slough Road; access to Slough Road is no longer possible without passing through the Beelman office and security area along Route 3.

Photograph 1: Slough Road, inside of fence along Bremen Street.

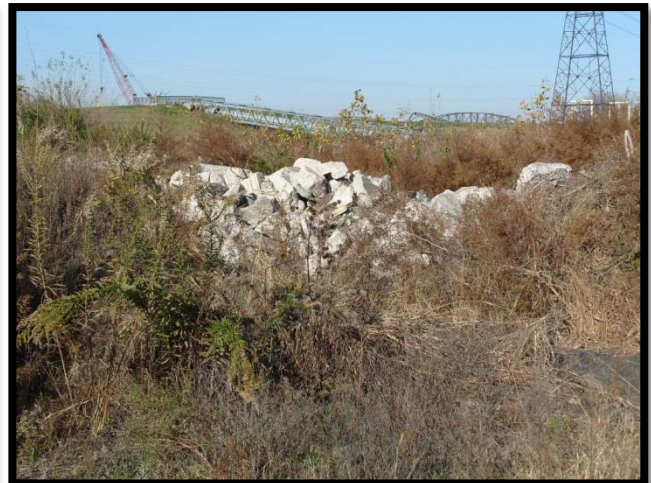
Photograph 4: Slough Road, concrete debris pile.

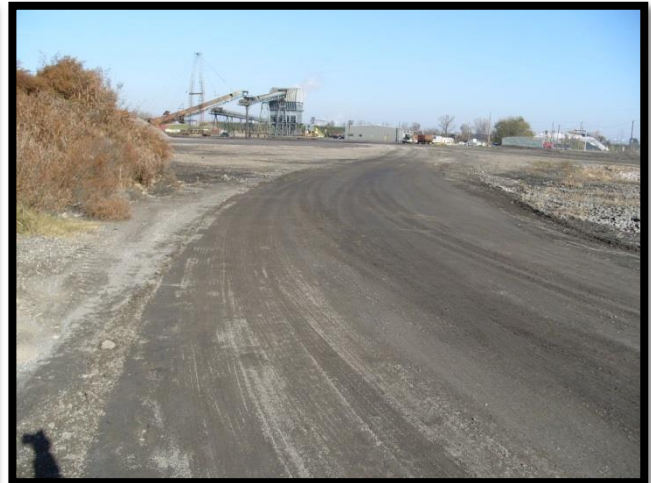
Photograph 6: Slough Road, roadway.

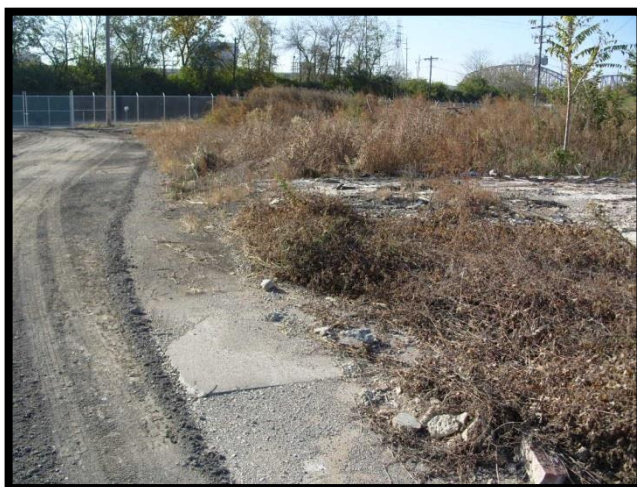
Photograph 7: Slough Road, roadway, foundation.

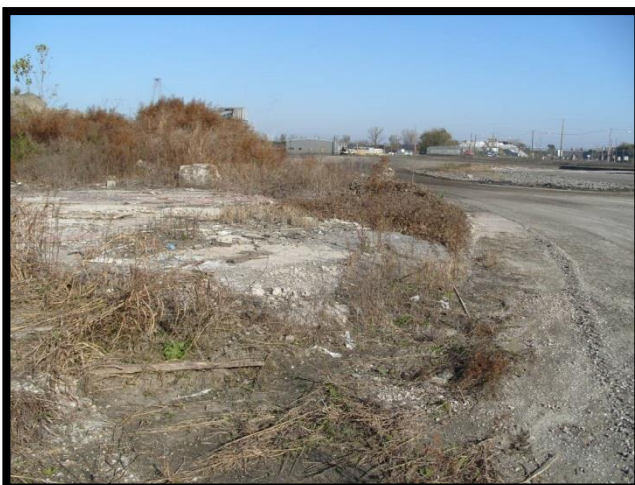
Photograph 10: Slough Road, roadway, foundation.

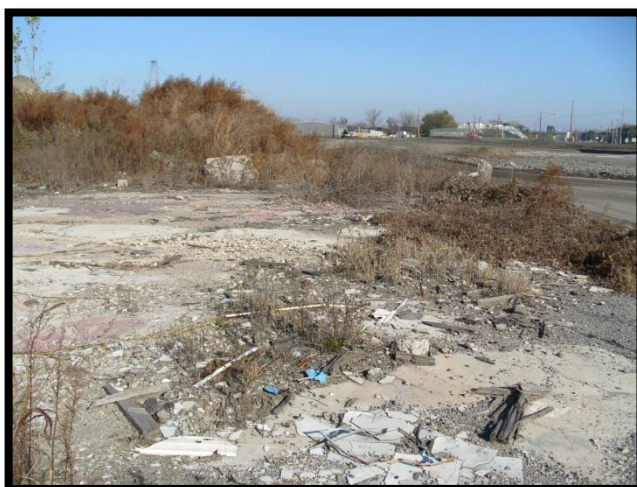
Photograph 11: Slough Road, concrete debris, foundation of former Robin's Nest Lounge.

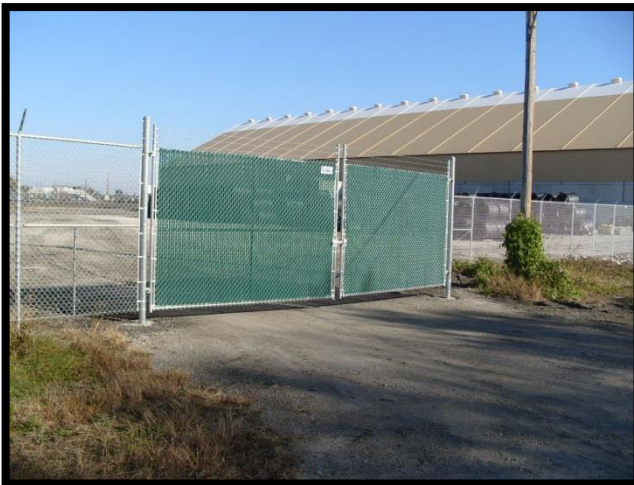
Photograph 15: Slough Road, outside of gate along Bremen Street.

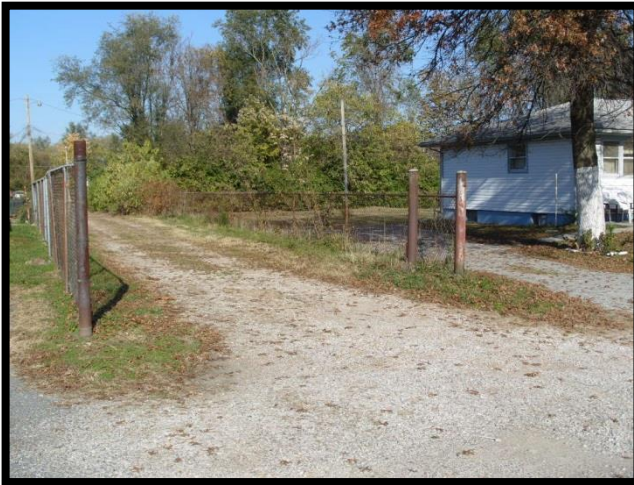
Photograph 1: Watson Alley, gravel area.

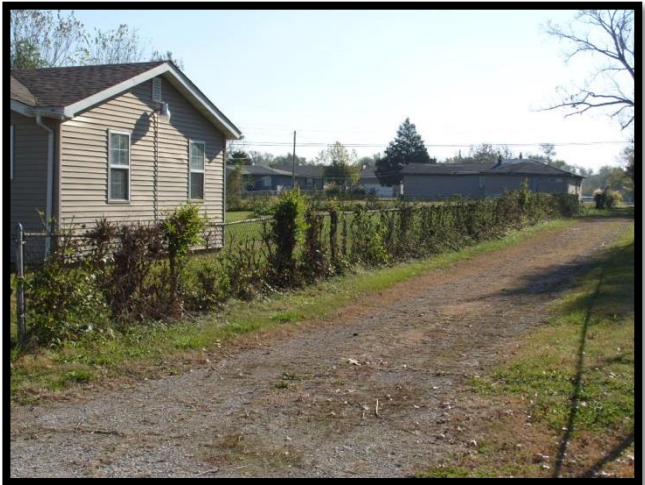
Photograph 2: Watson Alley, gravel area.

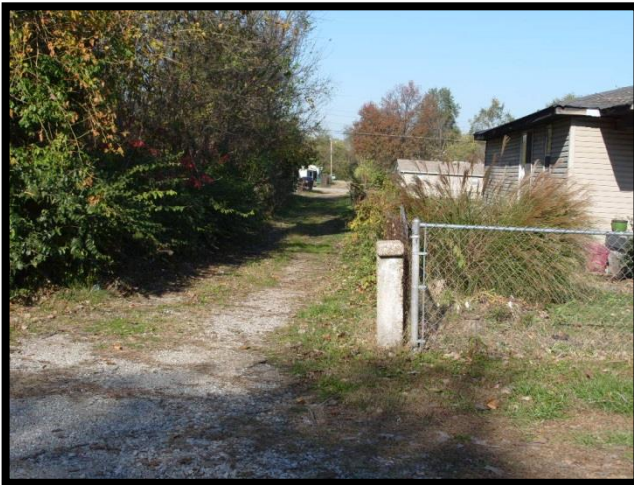
Photograph 3: Watson Alley, gravel area.

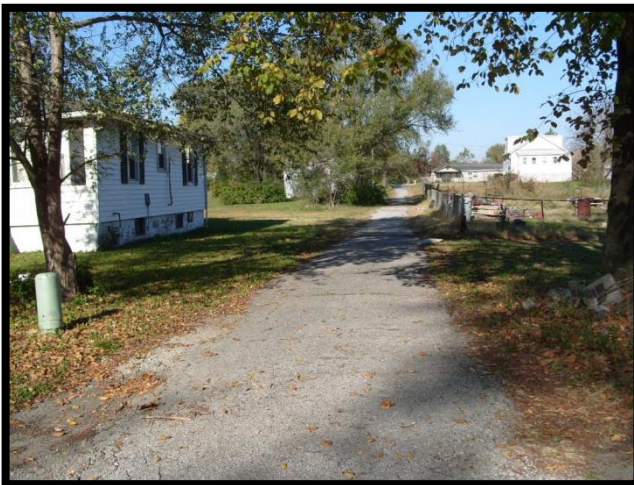
Photograph 5: Watson Alley, paved area (view from Watson Street).

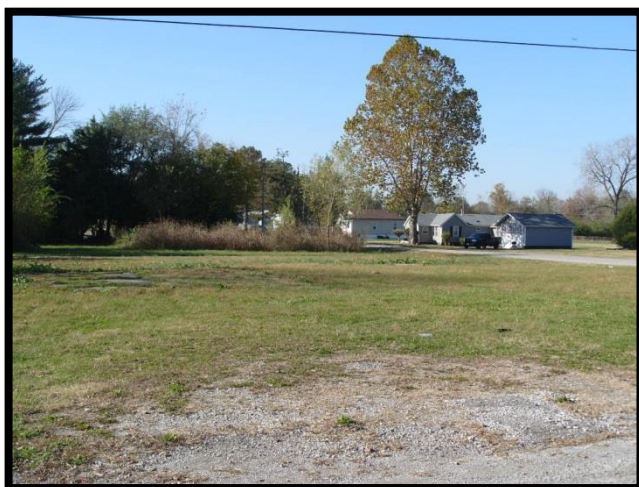
Photograph 1: 200 Harrison, also known as 200 Roosevelt Street (view from Roosevelt Street).

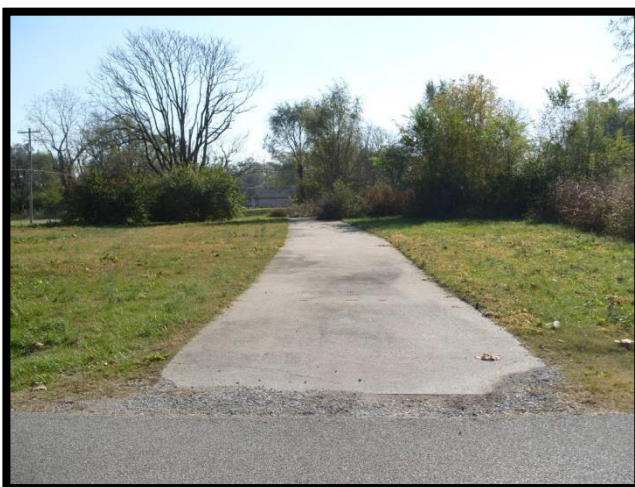
Photograph 2: 200 Harrison Street, also known as 200 Roosevelt Street (view from Harrison Street).

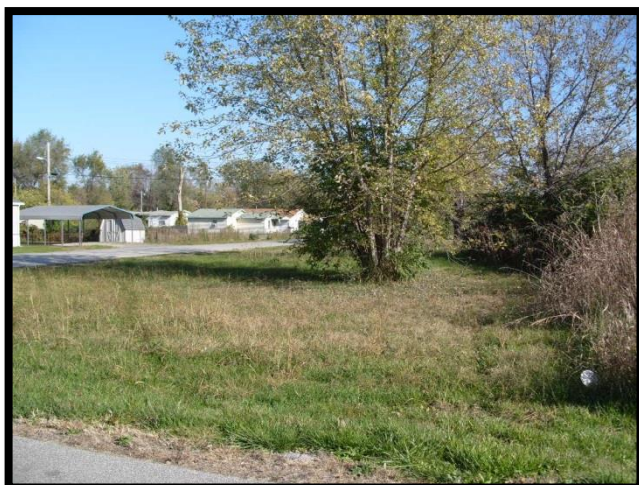
Photograph 3: 200 Allen Street (view from Allen Street).

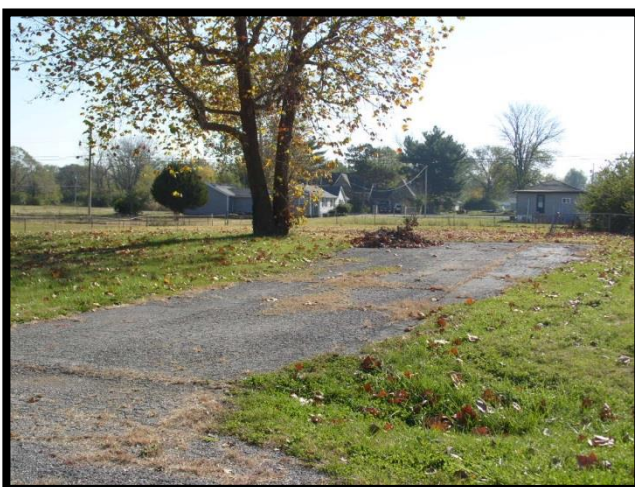
Photograph 6: 206 Terry Street (view from Terry Street).

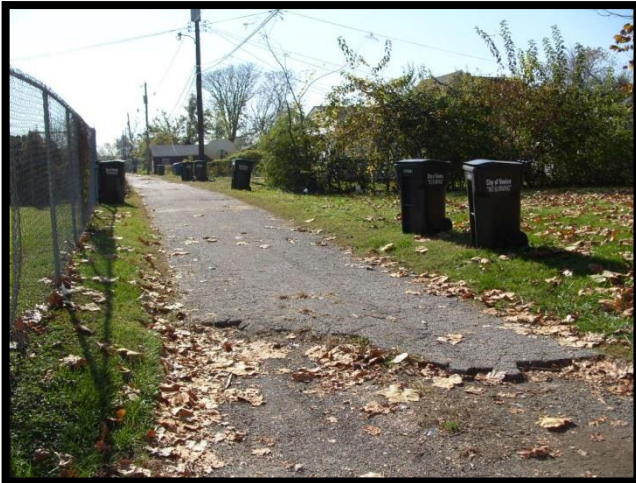
Photograph 3: Alley between Robin Street and Oriole Street (view south).

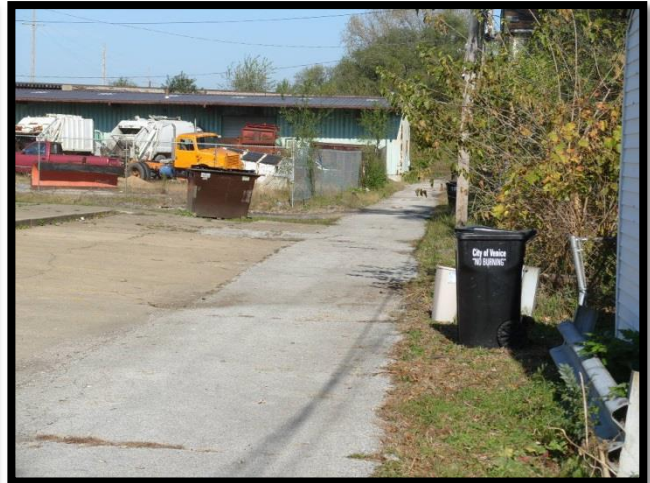
Photograph 4: Alley between Oriole Street and Klein Avenue (view north).

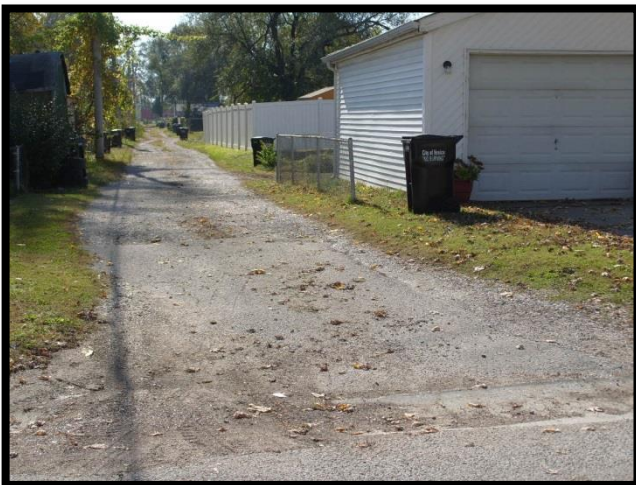
Photograph 5: Alley (gravel) between Oriole Street and Klein Avenue (view south).

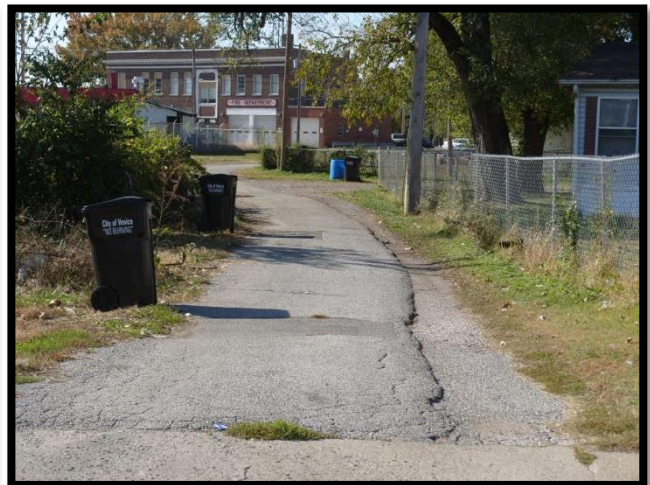
Photograph 6: Alley between Broadway and Oriole Street (view southwest).

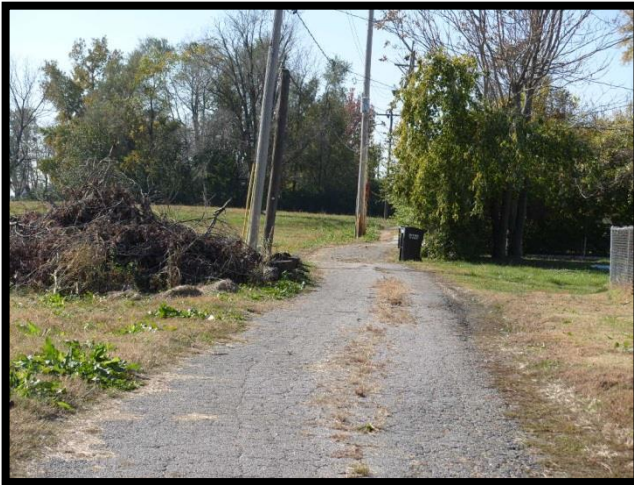
Photograph 7: Alley between Fillmore Avenue and Jefferson Street.

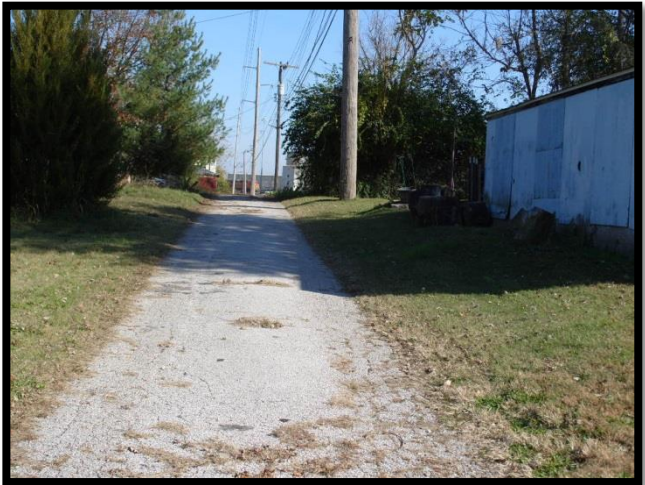
Photograph 8: Alley between Jefferson Street and Fillmore Street (view northeast from 6th Street).

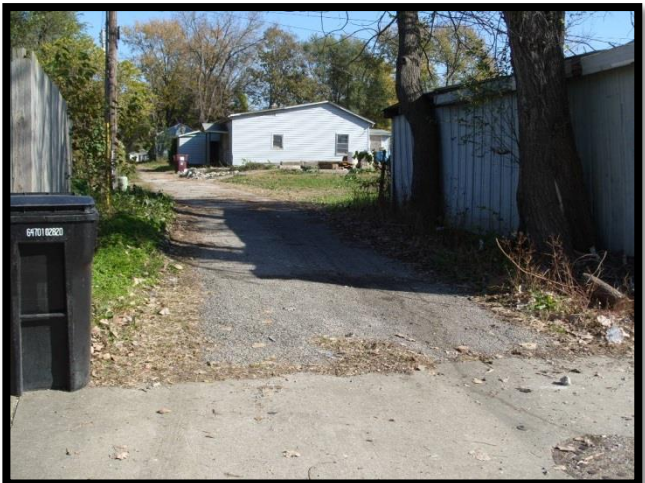
Photograph 10: Alley between Jefferson Street and Washington Street (view northeast from Klein Street).

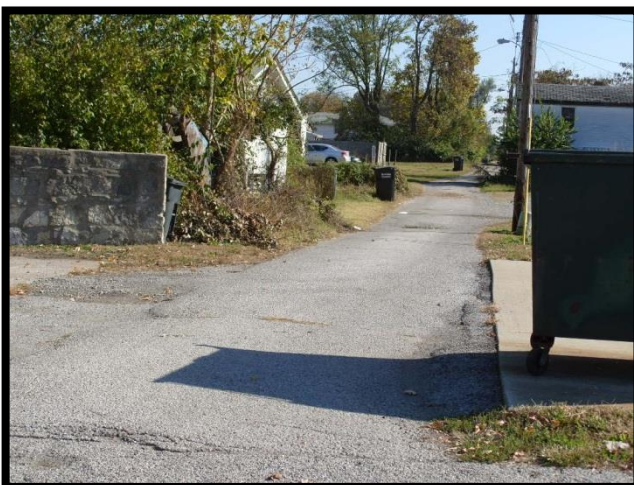
Photograph 11: Alley between Bissell Street and Market Street (view east from Baucum Street).

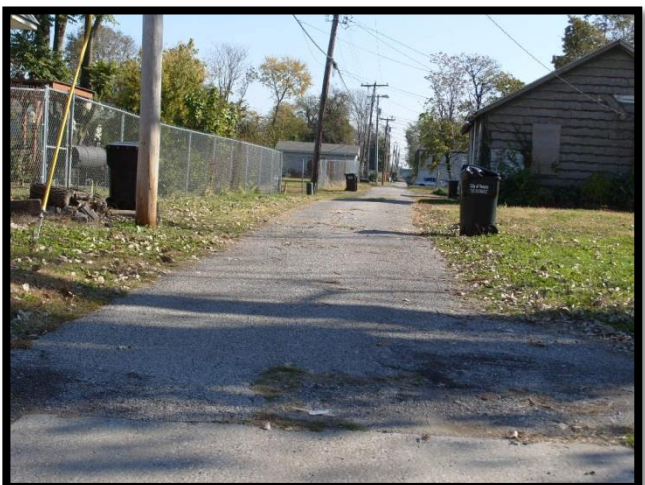
Photograph 12: Alley between Market Street and Logan Street (view east from Baucum Street).

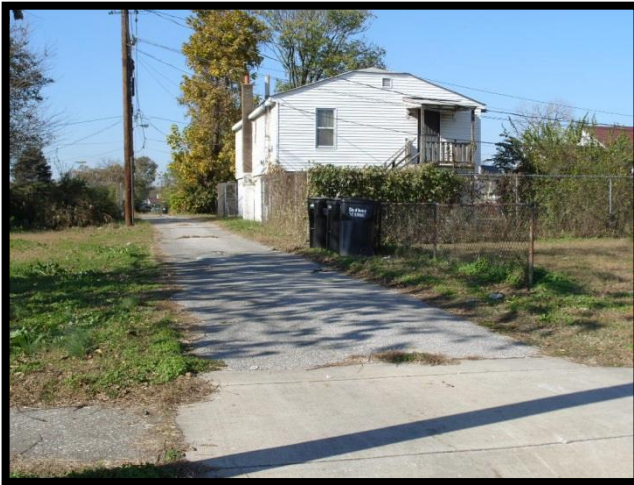
Photograph 13: Alley between Bissell Street and Market Street (view west from Meredocia Street).

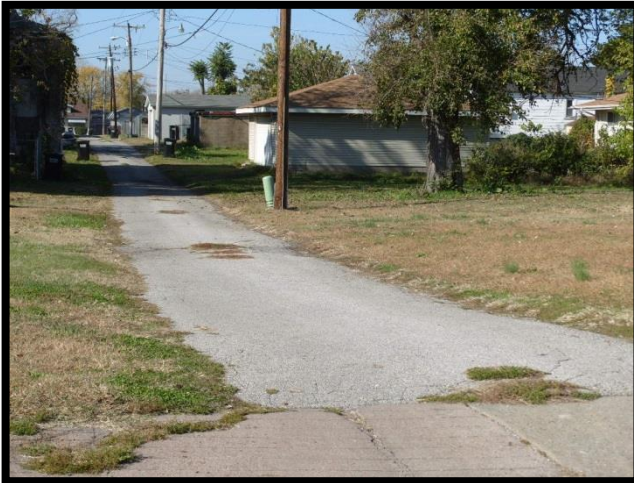
Photograph 15: Alley between Market Street and Logan Street (view west from Meredocia Street).

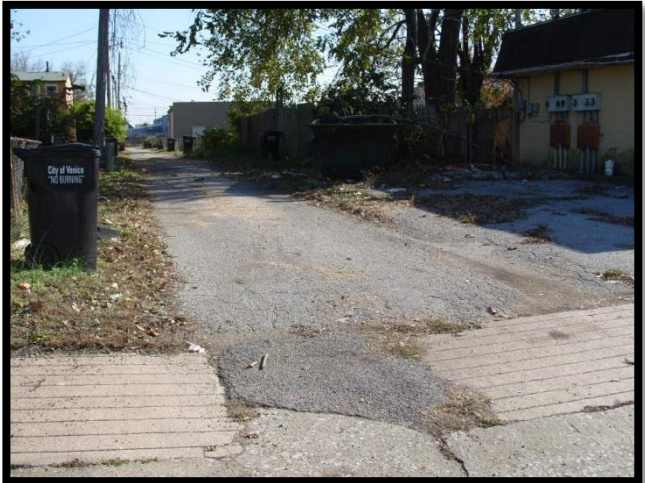
Photograph 16: Alley between Market Street and Logan Street (view east from Selb Street).

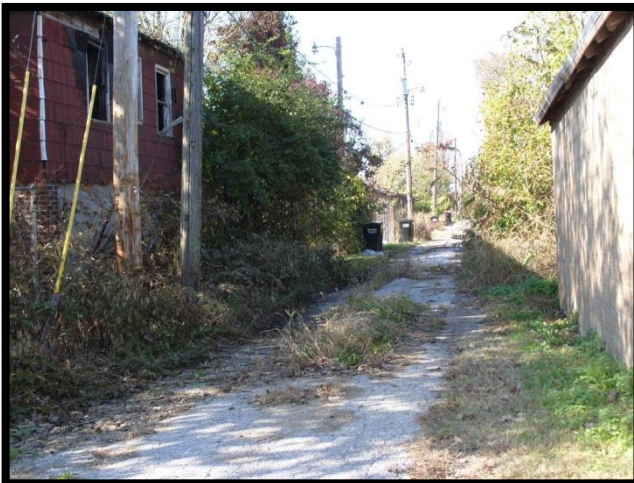
Photograph 17: Alley between Calhoun Street and Douglas Street (view west from Line Alley); several holes have been filled with asphalt since June 2012 inspection.

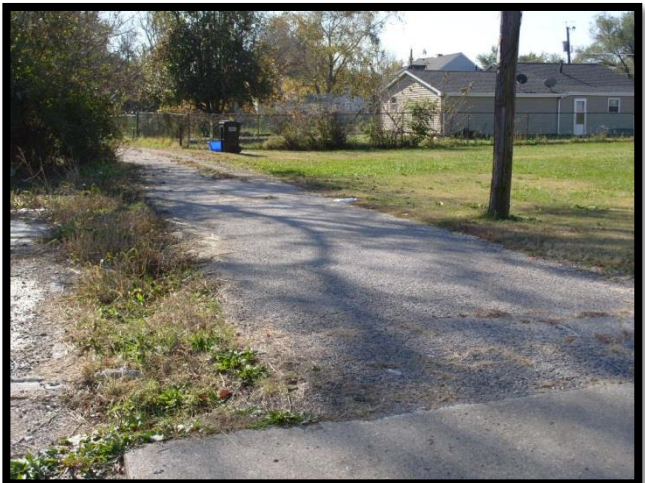
Photograph 18: Alley between Salveter Street and Meredocia Street (view south from Rogan Street).

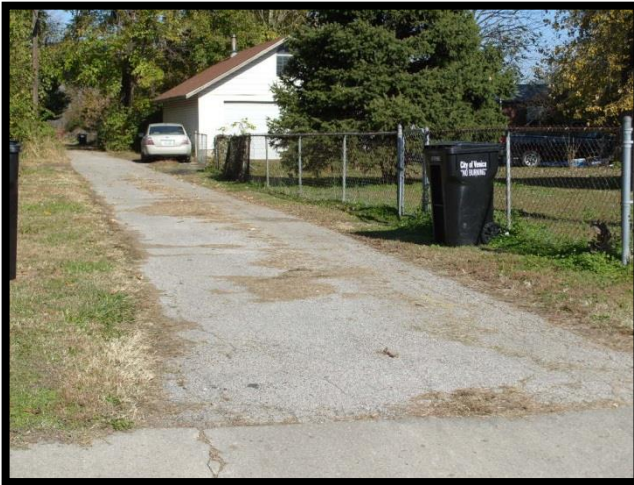
Photograph 19: alley between Allen Street and Rogan Street (view north from Allen Street).

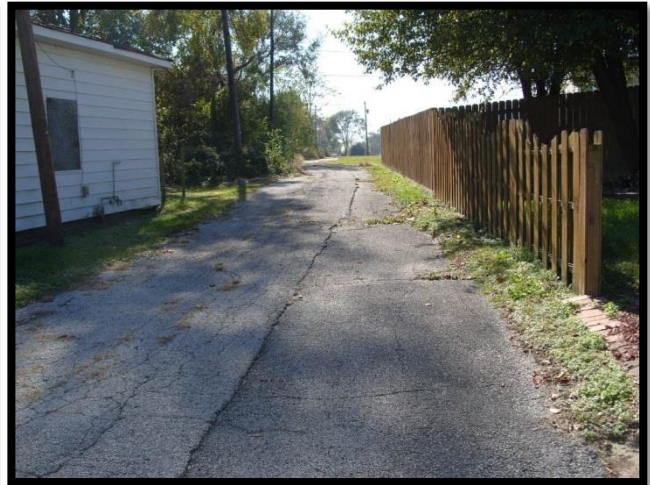
Photograph 20: Alley between Baicum Street and West 3rd Street (view south from Madison Street and College Street).

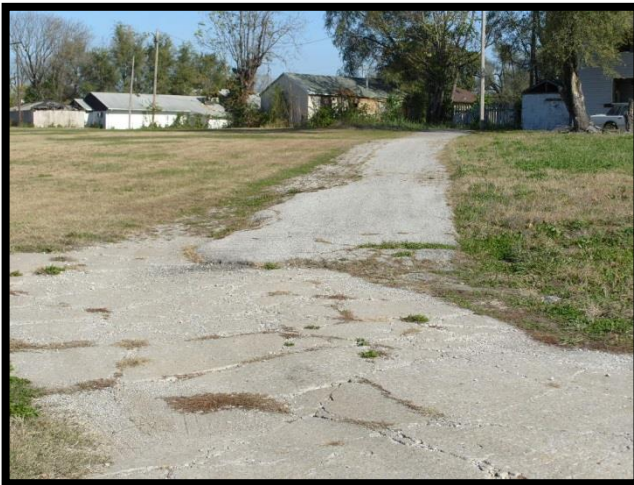
Photograph 21: Alley on Jackson Street (between 3rd Street and Baicum Street).

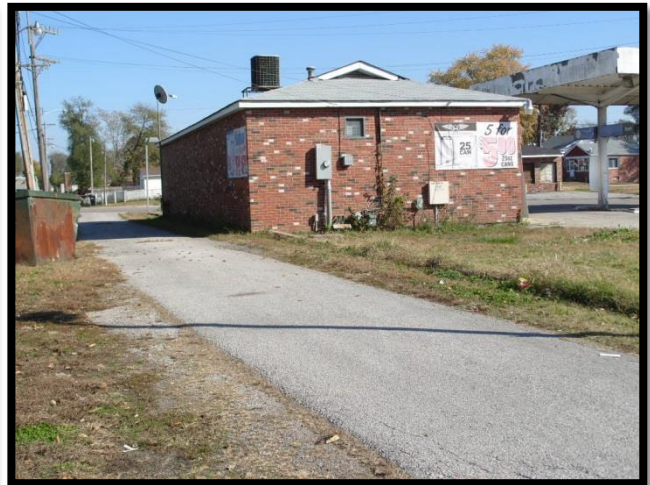
Photograph 22: Alley between 4th Street, Broadway, and Lincoln Avenue.

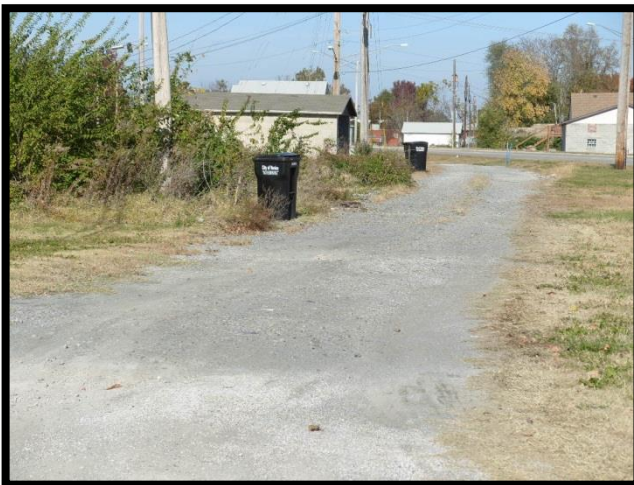
Photograph 23: Alley (gravel) between 3rd Street and 4th Street (view north from Abbott).

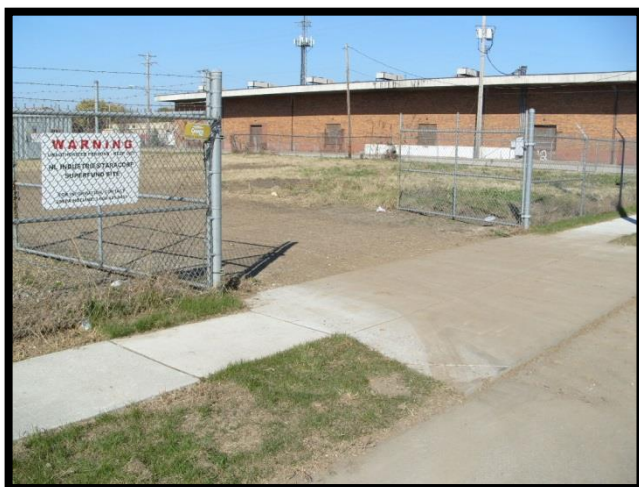
Photograph 1: Entrance to 1555 State Street property along State Street.

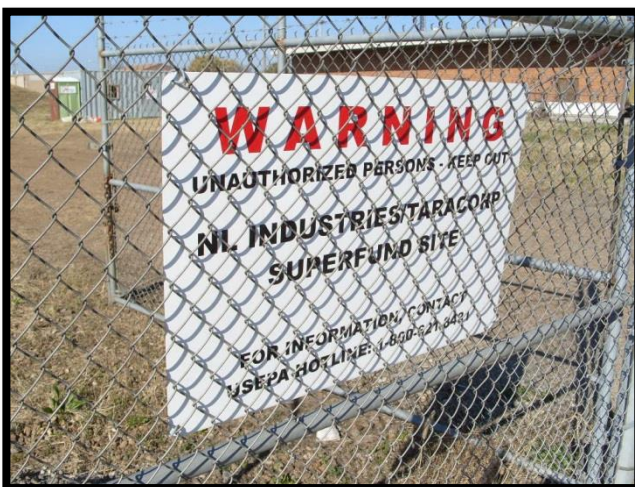
Photograph 2: Warning sign at front gate along State Street.

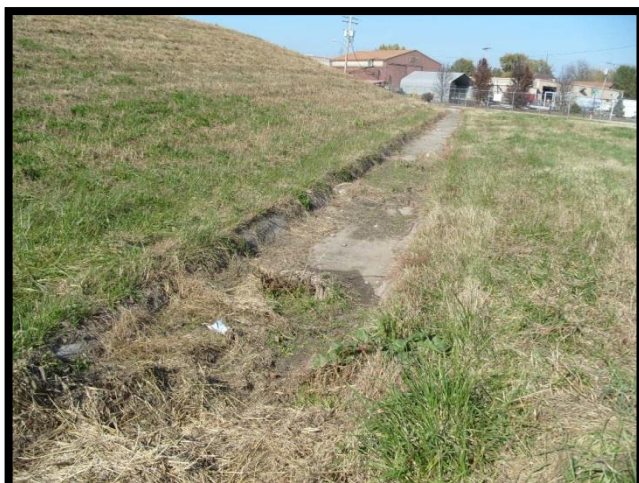
Photograph 3: Concrete drainage swale, south side of Taracorp pile (view north).

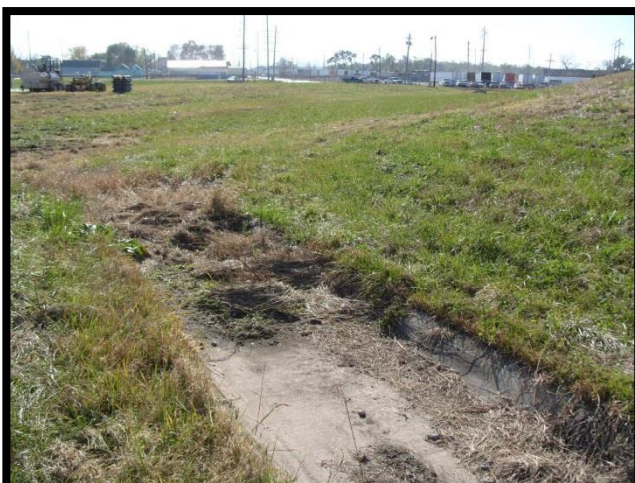
Photograph 4: End of concrete drainage swale, south side of Taracorp pile.

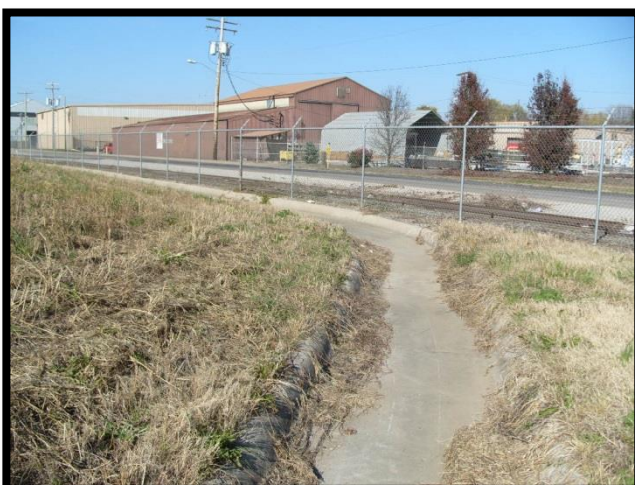
Photograph 6: Concrete drainage swale, east side of Taracorp pile (view north).

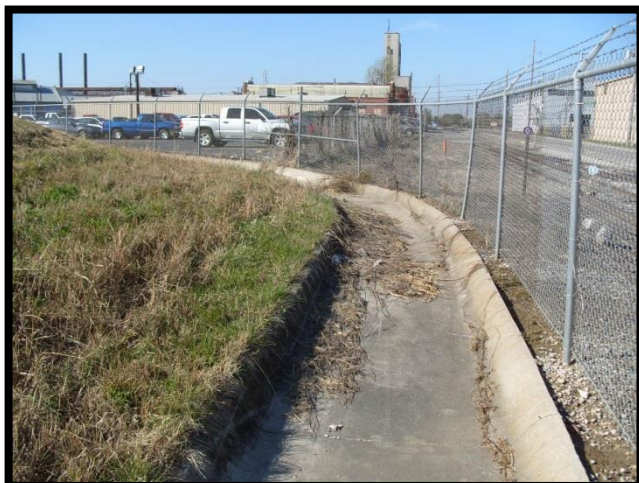
Photograph 9: Concrete drainage swale, fence, and vegetation; northeastern side of Taracorp pile along 16th Street (view northwest).

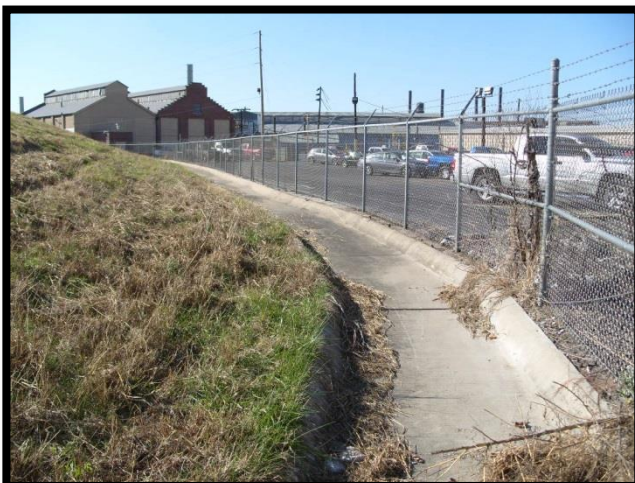
Photograph 10: Concrete drainage swale and vegetation, northwestern side of Taracorp pile (view southwest).

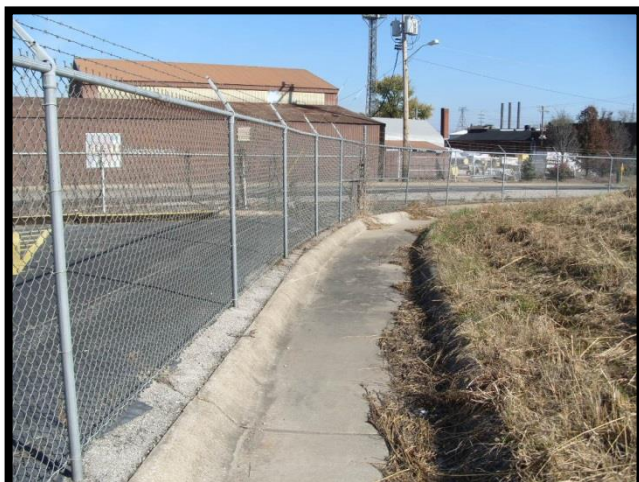
Photograph 11: Concrete drainage swale and vegetation, northwestern side of Taracorp pile (view northeast).

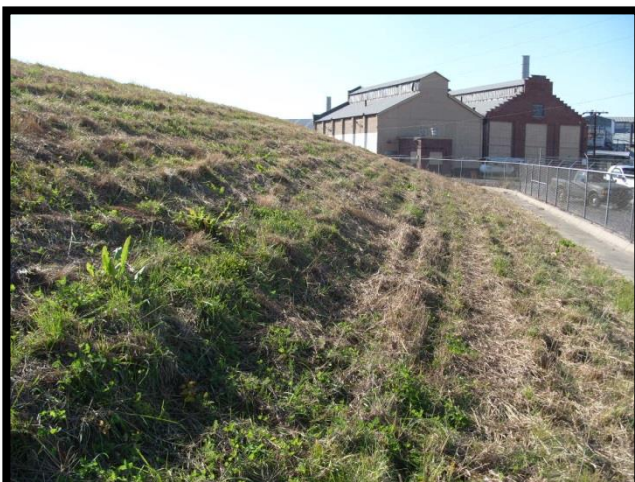
Photograph 12: Vegetation, northwestern side of Taracorp pile cap (view southwest).

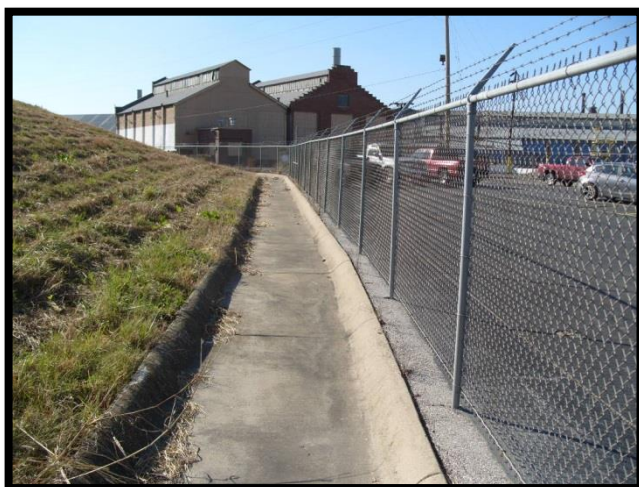
Photograph 13: Concrete drainage swale, fence, and vegetation along northwestern side of Taracorp pile (view southwest).

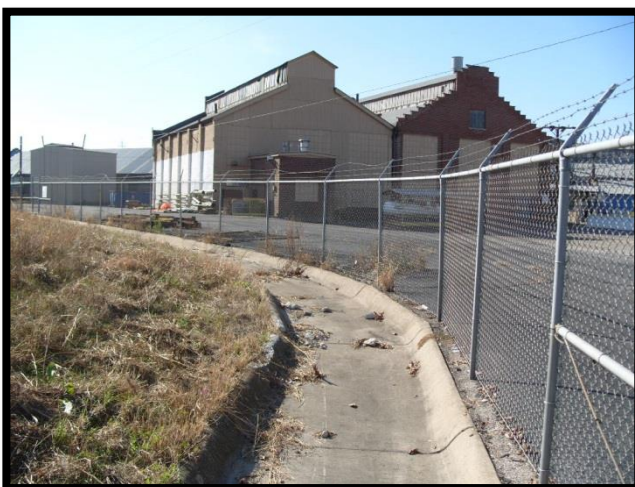
Photograph 14: Concrete drainage swale, fence, and vegetation along northwestern side of Taracorp pile (view southwest).

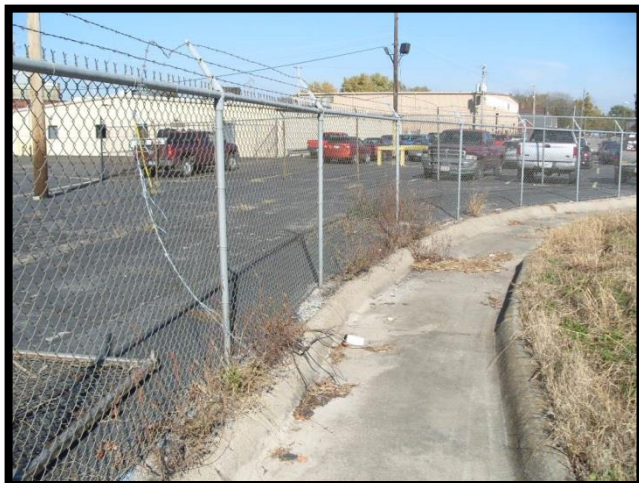
Photograph 15: Concrete drainage swale, vegetation along northwestern side of Taracorp pile (view north/northeast).

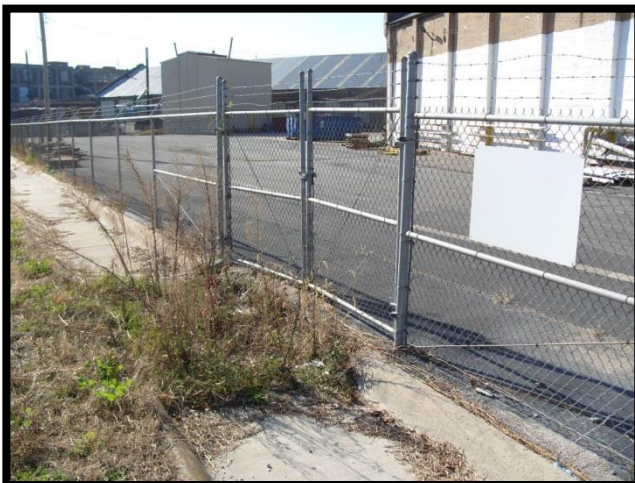
Photograph 16: Fence, warning sign, and gate northwestern side of Taracorp pile (view southwest).

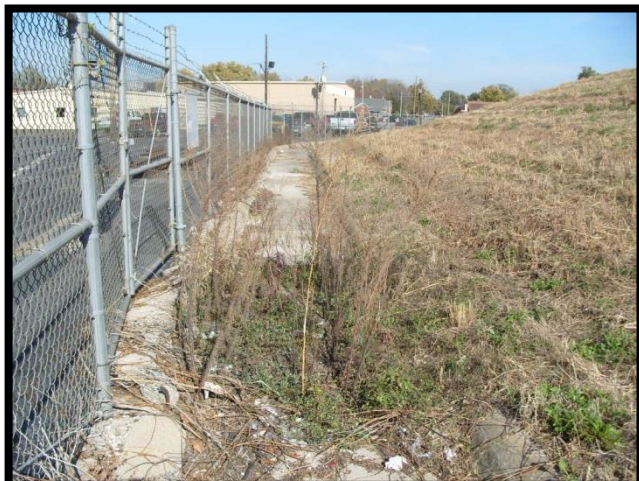
Photograph 17: Vegetation near base of west side of Taracorp pile (view northeast).

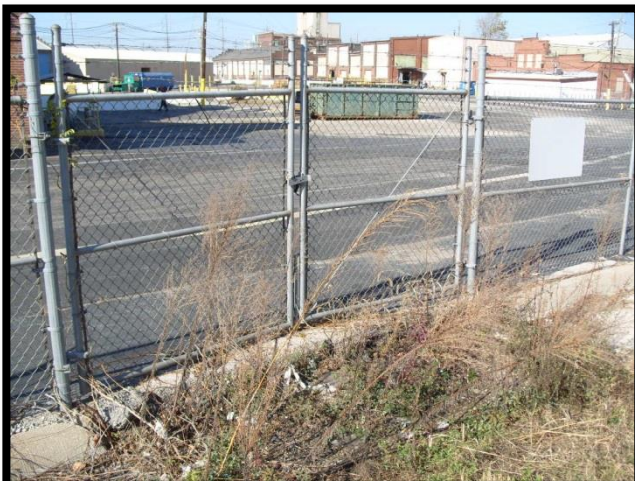
Photograph 18: Fence, gate, and warning sign along northwestern side of Taracorp pile (view northwest).

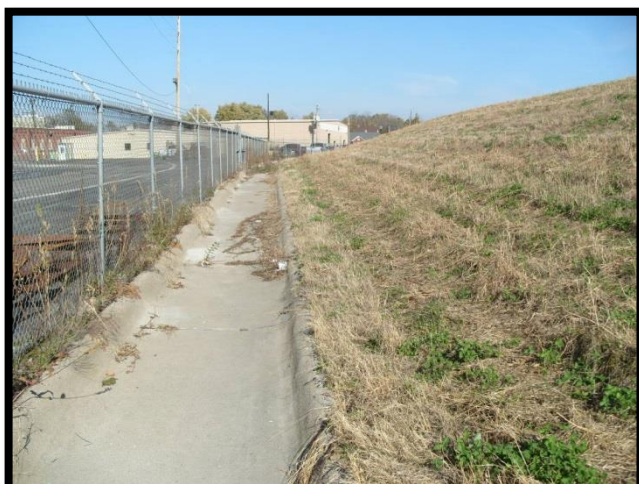
Photograph 19: Vegetation near base of western side of Taracorp pile (view north).

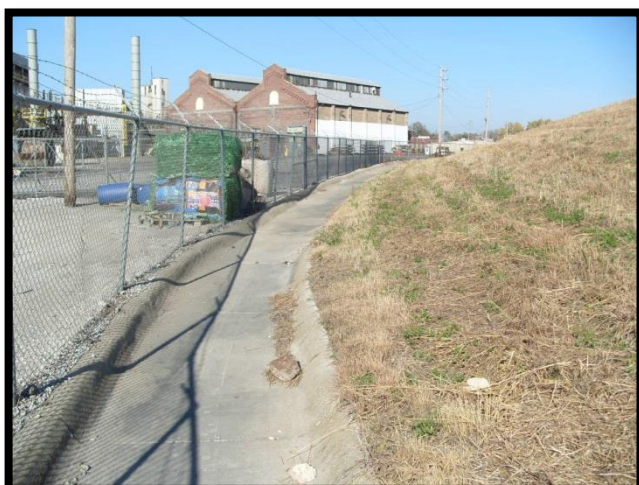
Photograph 23: Concrete drainage swale and vegetation near base of western side of Taracorp pile (view north).

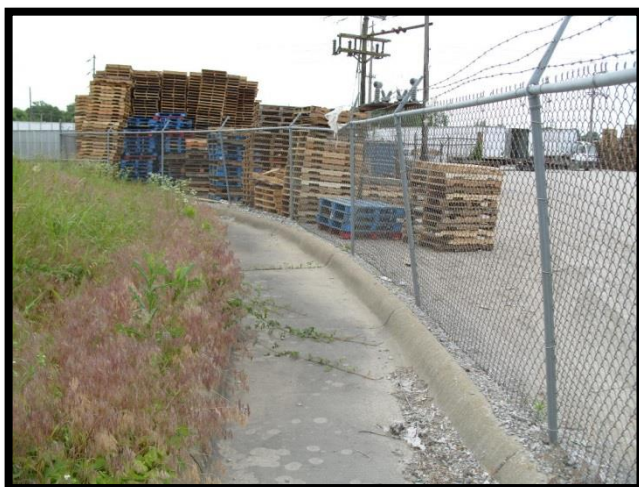
Photograph 25: Fence and concrete drainage swale (southwestern side of Taracorp pile cap).

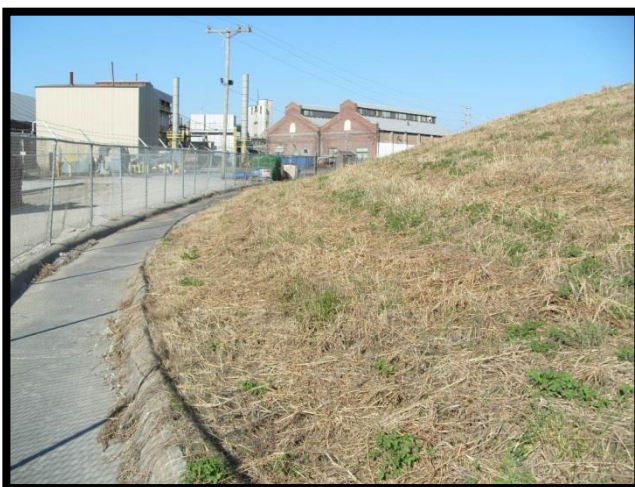
Photograph 26: vegetation near base of southwestern side of Taracorp pile (view northwest).

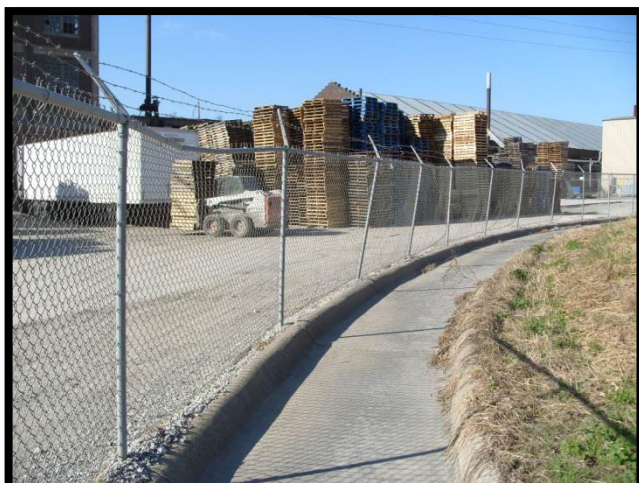
Photograph 27: Fence and concrete drainage swale (southwestern side of Taracorp pile cap).

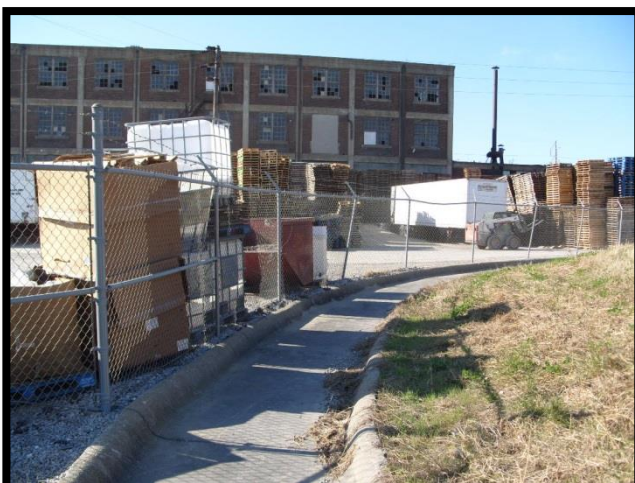
Photograph 28: Fence and concrete drainage swale (southwestern side of Taracorp pile cap).

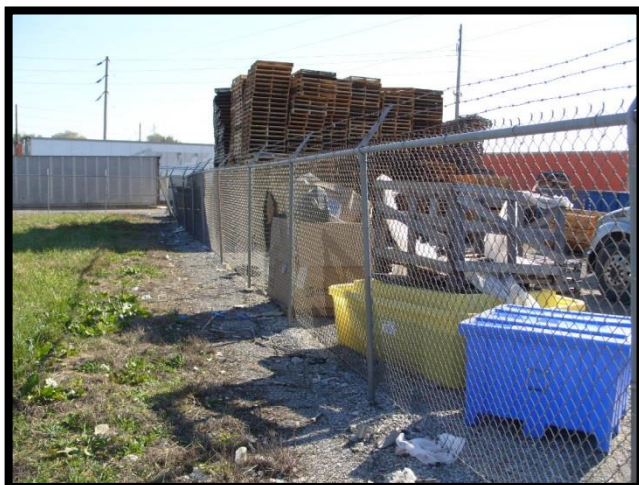
Photograph 29: Fence (material staging on State Street Warehouse property).

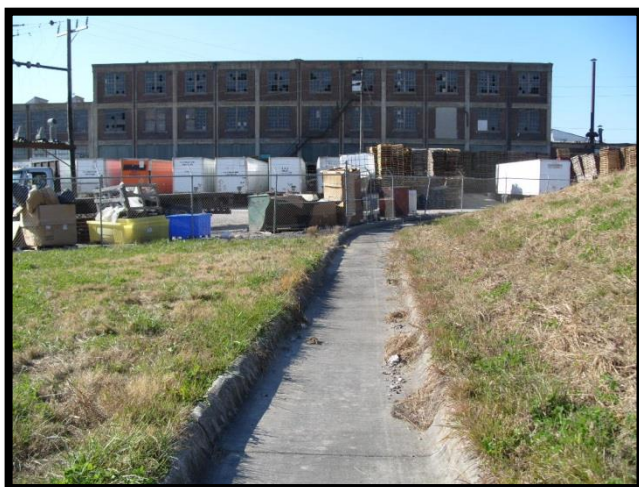
Photograph 31: Vegetation and concrete drainage swale along southwestern slope of Taracorp cap pile (view west).

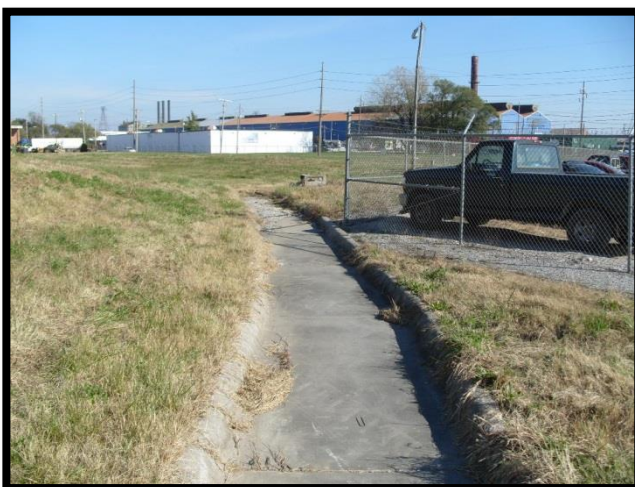
Photograph 32: Concrete drainage swale along southern slope of Taracorp pile.

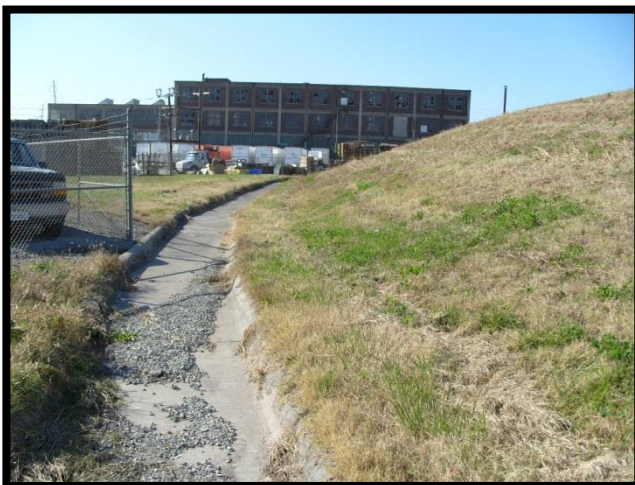
Photograph 34: Concrete drainage swale along southern slope of Taracorp pile.

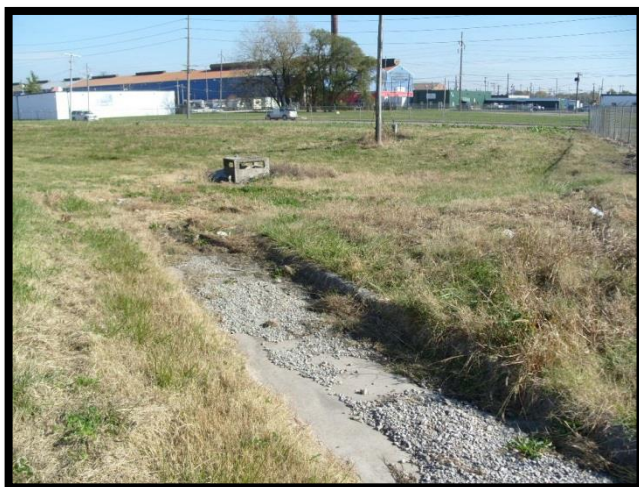
Photograph 35: Vegetation along southeast side of Taracorp pile cap (view northeast).

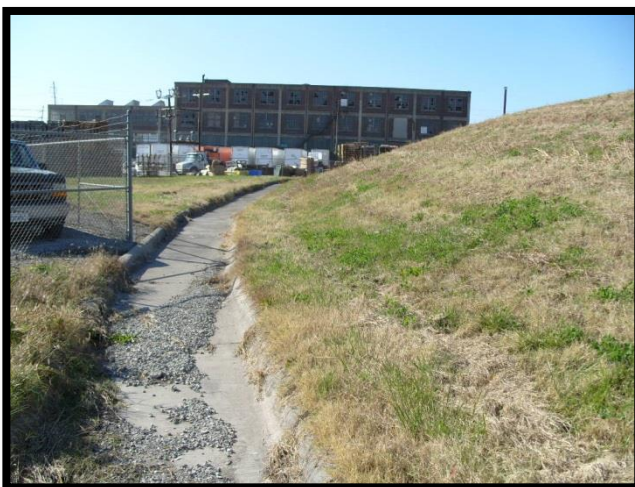
Photograph 36: Southern side of Taracorp pile (view west).

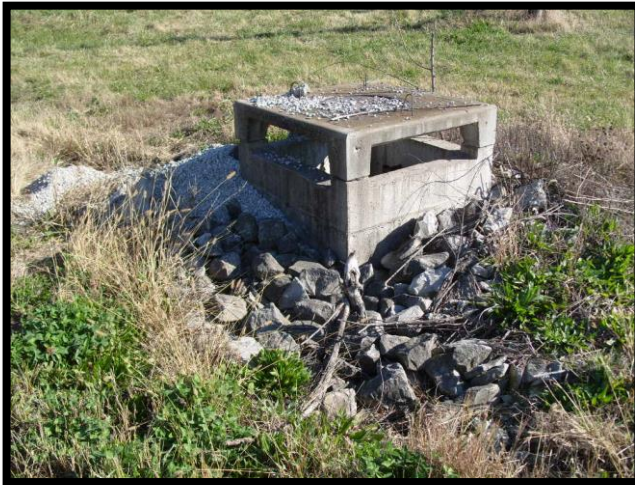
Photograph 37: Storm water outlet.

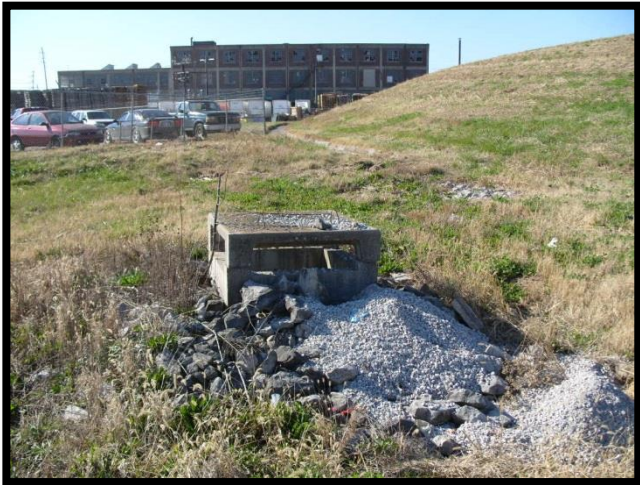
Photograph 38: Storm water outlet.

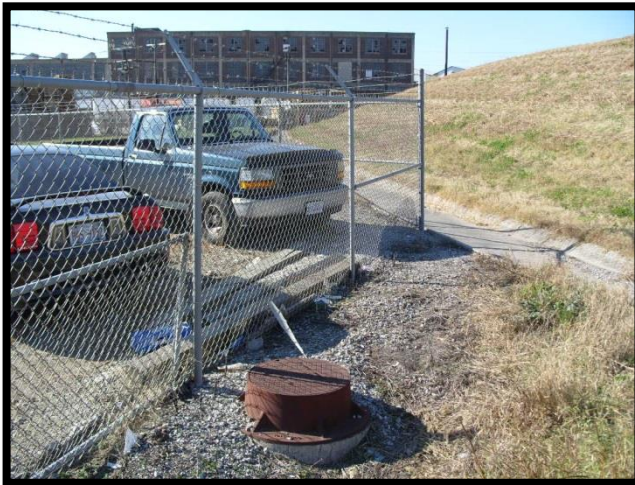
Photograph 39: Storm water manhole near fence.

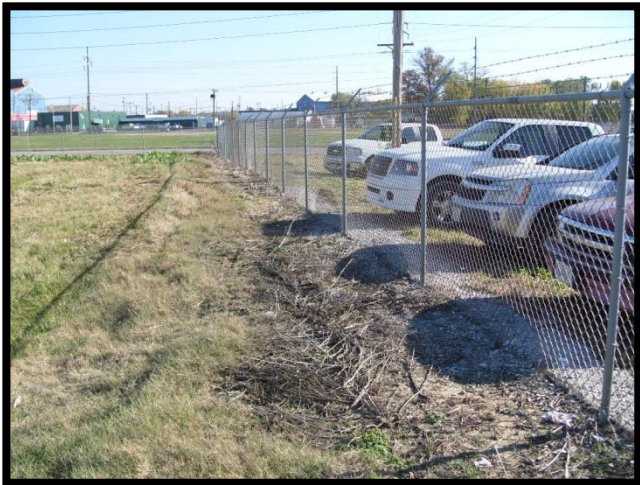
Photograph 40: Vegetation and fence near former Rich Oil facility (view toward State Street).

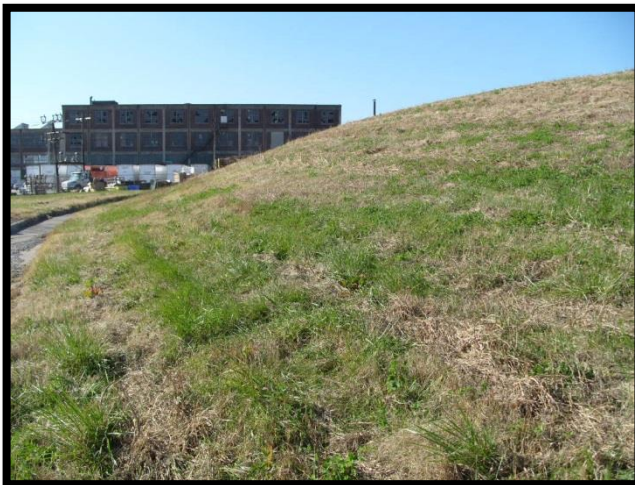
Photograph 41: Vegetation, southern side of Taracorp pile cap.

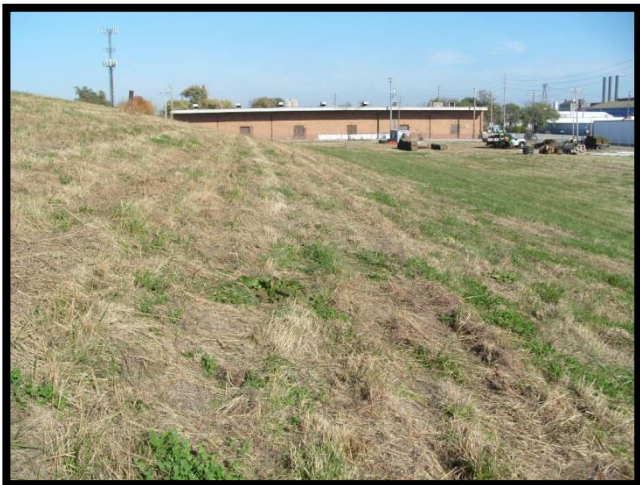
Photograph 42: Vegetation, eastern side of Taracorp pile cap.

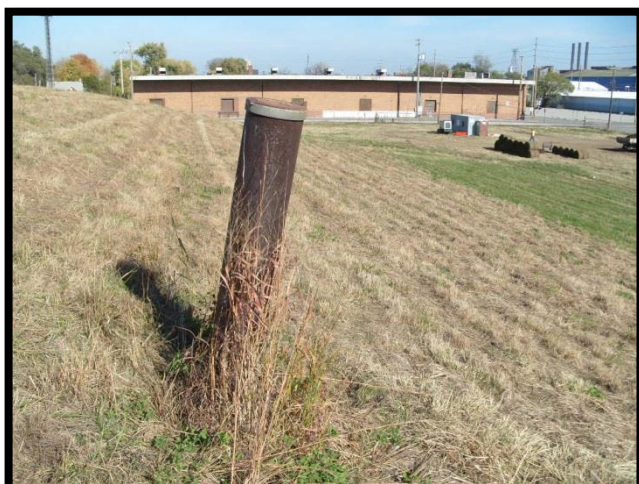
Site Structure	Inspected (yes/no)	Inspection Observations	Maintenance Work Performed or Required
Leachate Management System			
Riser pipe and locks	Yes	Riser pipe clean and in good condition. The lid on the riser pipe was locked.	
Leachate levels in sump	No	EWI removed leachate from the sump in June 2014 as part of the five-year review groundwater monitoring event.	
Necessary sampling activities	No		
Necessary leachate disposal	No		
Comments			
Concrete Drainage Channel			
Evidence of cracks or obstructions	Yes	No significant cracks or obstructions.	
Areas of erosion	Yes	No erosion observed.	
Comments			
Asphalt Covers - Integrity			
Evidence of broken asphalt or fissures	Yes	Some minor asphalt cracking and deterioration was observed in small areas along the sides of several paved alleys in Venice. Evidence of recent paving / patching of the alleys by Venice Township was observed along 6th Street (Attachment 4, photograph 9).

Photograph 43: Leachate riser pipe.
